LIGHTWEIGHT GEARBOX DEVELOPMENT FOR
PROPELLER GEARBOX SYSTEMS APPLICATIONS
POTENTIAL COATINGS FOR TITANIUM ALLOY
GEARS

**Detroit Diesel Allison Division
General Motors Corporation
Indianapolis Operations**

TECHNICAL REPORT AFAPL-TR-72-90

December 1972

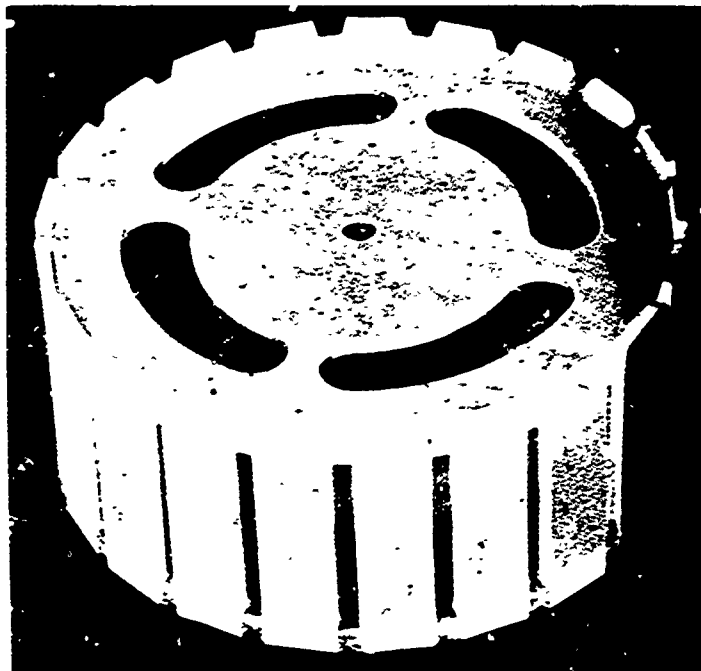
7326-12

Figure 11. Mask with adjustable slot sizes.

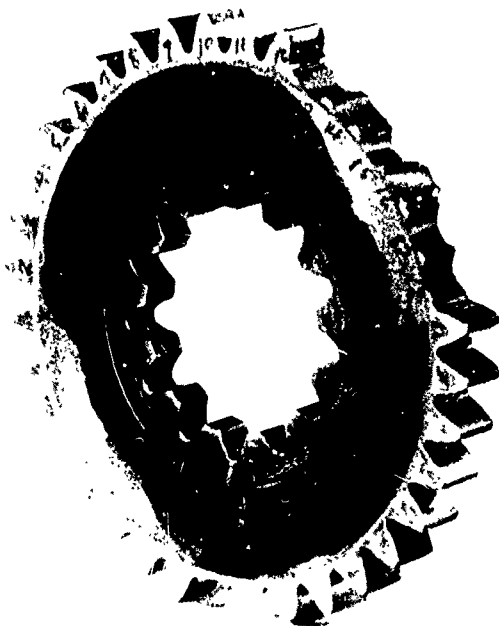
7326-57

Test I. 3—Fracture of narrow gear teeth resulted from multiple indications of fatigue failure in the area of high nickel concentration in the tooth root fillet area. Figure 57 shows the fractured tooth failures.
